Hyster-Yale Greenville, NC :

DYNAMIC DRAIN
TECHNOLOGIES
PIPELINING PROFESSIONALS

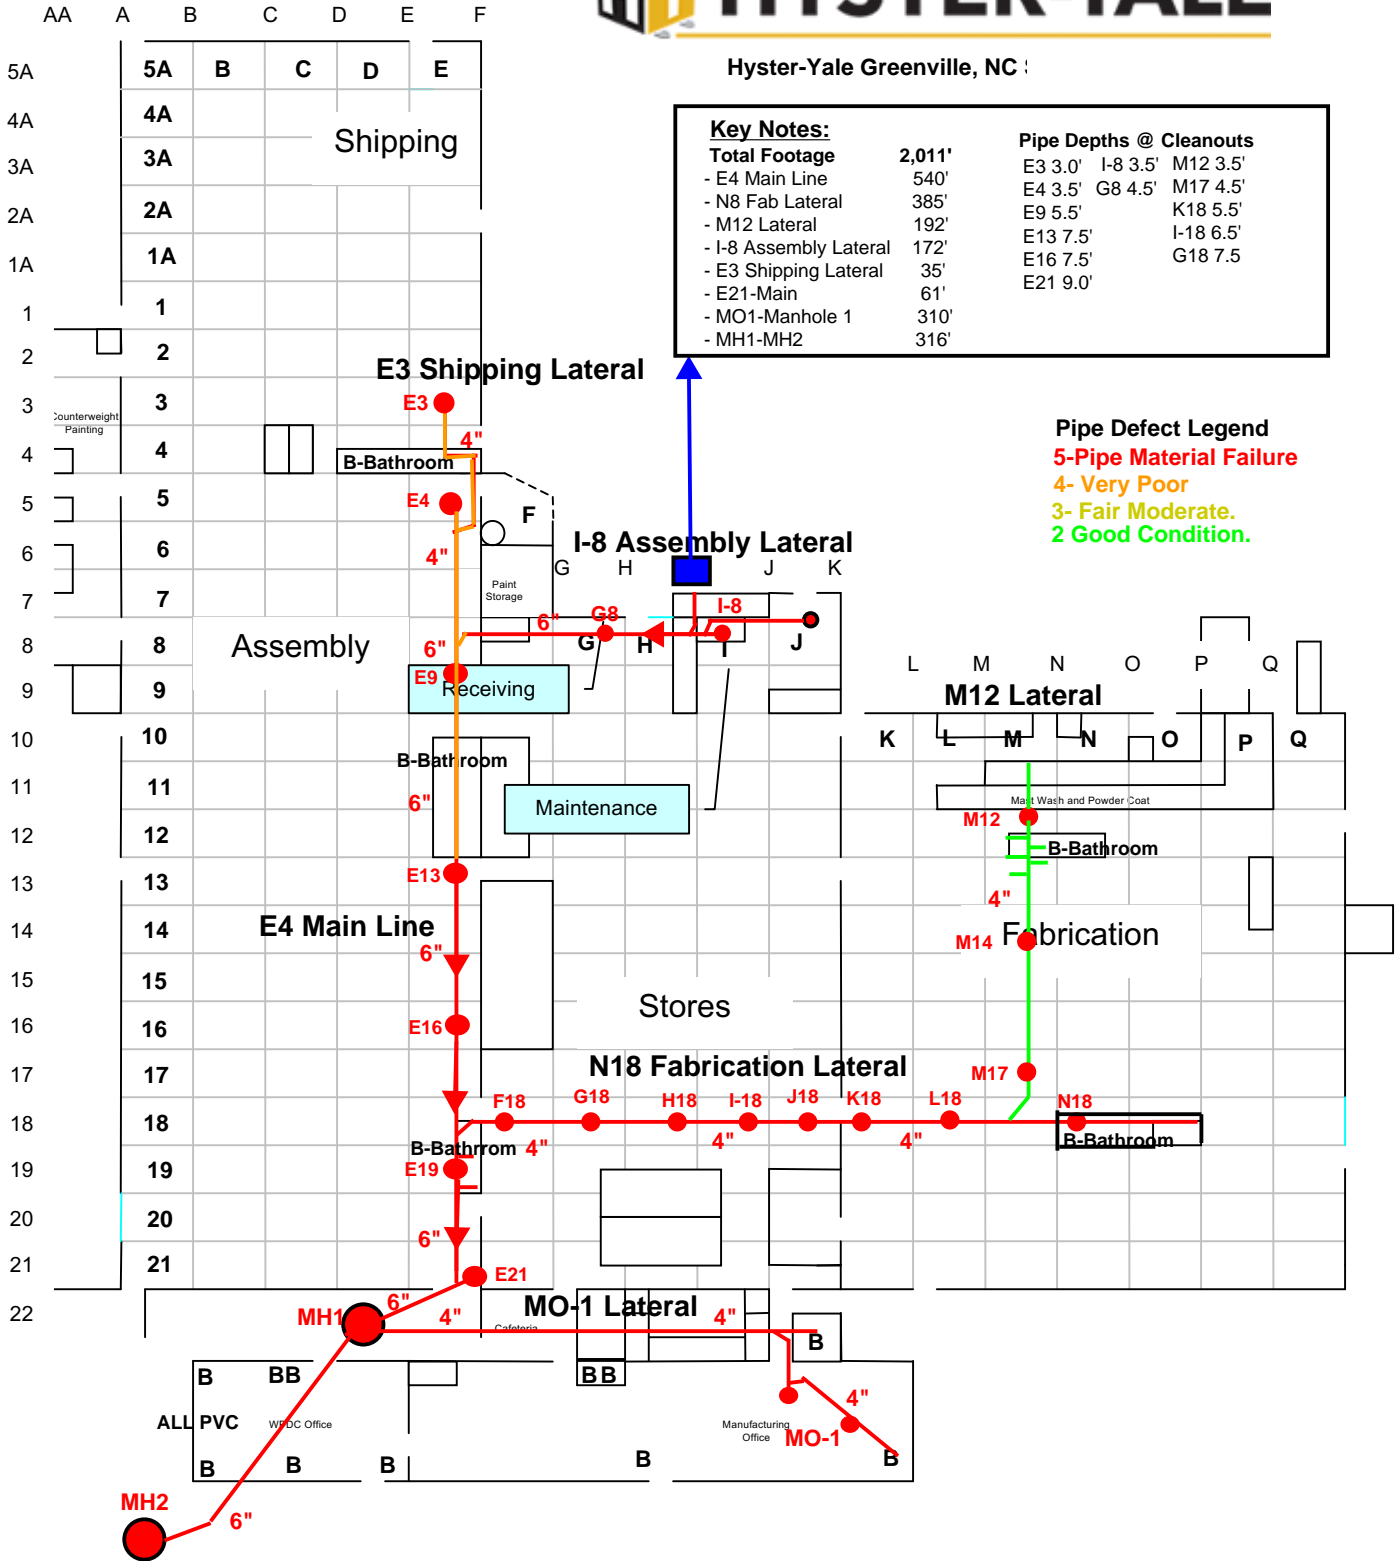
Total Footage	2,011'
- E4 Main Line	540'
- N8 Fab Lateral	385'
- M12 Lateral	192'
- I-8 Assembly Lateral	172'
- E3 Shipping Lateral	35'
- E21-Main	61'
- MO1-Manhole 1	310'
- MH1-MH2	316'

E3 3.0'	I-8 3.5'	M12 3.5'
E4 3.5'	G8 4.5'	M17 4.5'
E9 5.5'		K18 5.5'
E13 7.5'		I-18 6.5'
E16 7.5'		G18 7.5'
E21 9.0'

- 5- Pipe Material Failure
- 4- Very Poor
- 3- Fair Moderate.
- 2 Good Condition.
