Bolling Brook Sewer Riser Inspections - Building 3242

A Sanitary Sewer Evaluation Study is a technological method of scoring piping defects within sewer infrastructure. This top down method incorporates: surveys, pipe inspections, and evaluation concepts into a turnkey, professional service delivering detailed, conditional assessments for any major collection system. Our analytical process digitally overlays pipe locations with each pipes' conditional data points to provide a concise, quantifiable survey that are scored relative to the risk of the infrastructure failing. This information serves as an invaluable tool for assessing and planning short and long-term infrastructure rehabilitation projects.

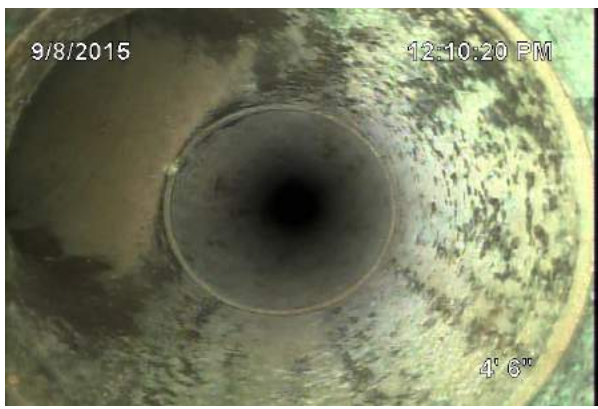
4' 6"

2" Connection. SCP - surface corrosion present - continuous.

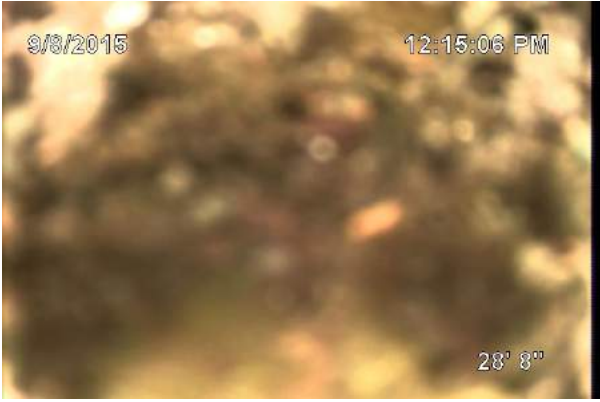
9/8/2015 12:15:07 PM 28' 8"

End inspection. MSA - survey abandoned due to number of bends preventing further progress. End continuous surface corrosion (SCP).

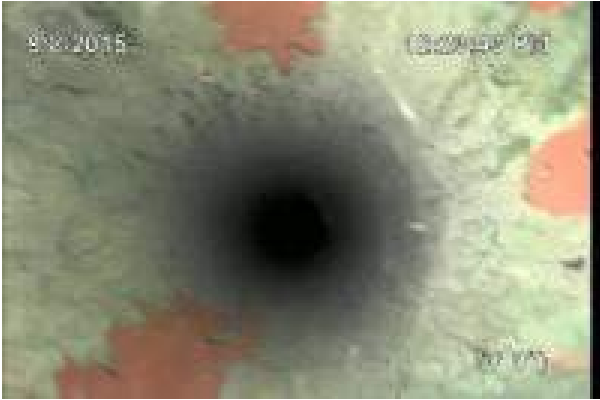
9/8/2015 12:23:44 PM 0' 0"

Start inspection. Access Sewer Riser. SCP - surface corrosion (scaling) - continuous.

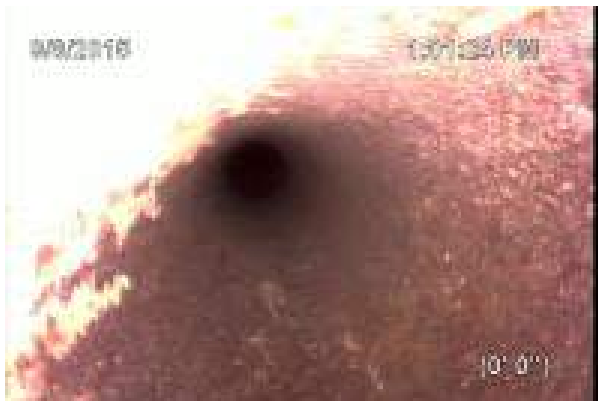
0' 0"

Start inspection. Access Sewer Riser. SCP - surface corrosion (scaling) - continuous.

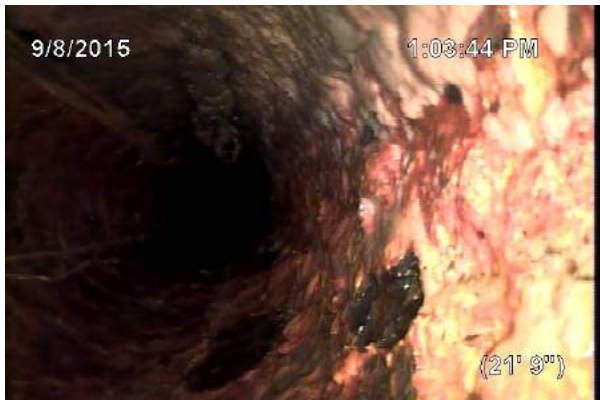
21' 9"

9/8/2015 1:03:44 PM
DAGS - grease deposits - continuous.

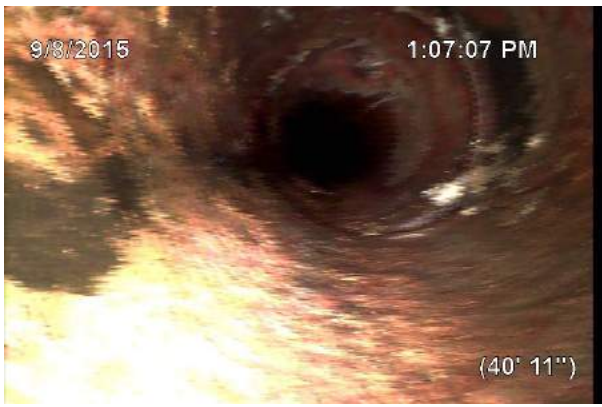
40' 11"

End inspection. MSA - survey abandoned at bottom of vertical riser. End continuous scale (SCP). End continuous grease deposits (DAGS).

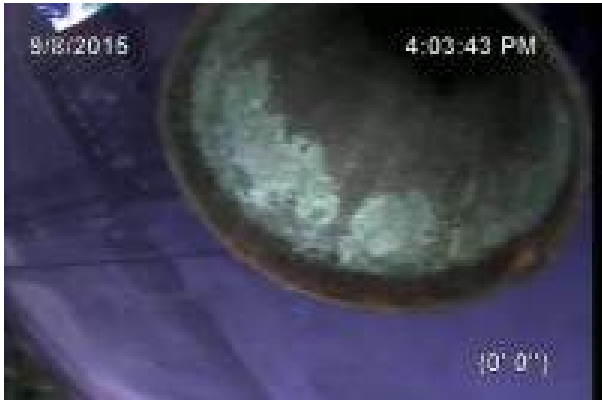
0' 0"

Start inspection. Access Sewer Riser. SCP - surface corrosion (scaling) - continuous.

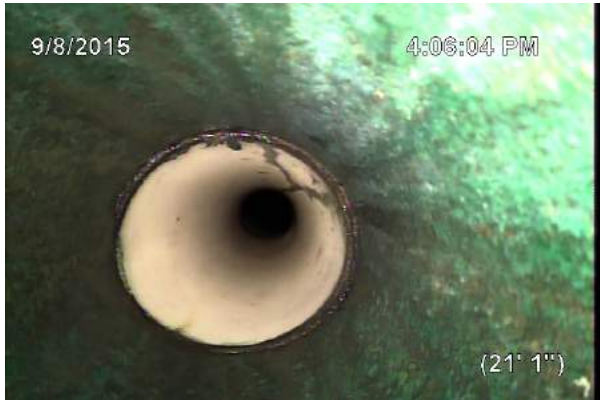
21' 1"

9/8/2015 4:06:04 PM
PRR - point repair

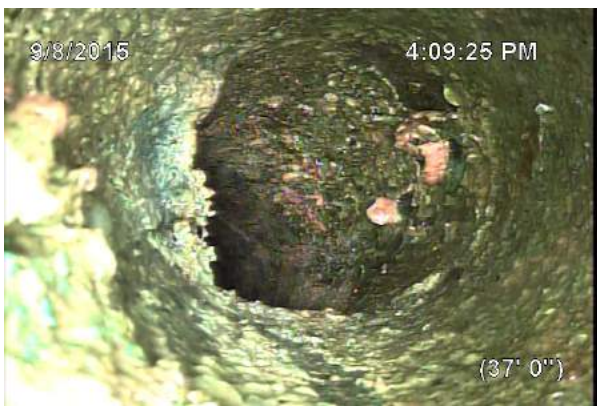
37' 0"

Defect score: 5 - very heavy corrosion and a hole observed.

9/8/2015 4:09:26 PM
H - hole @ 1 o'clock.

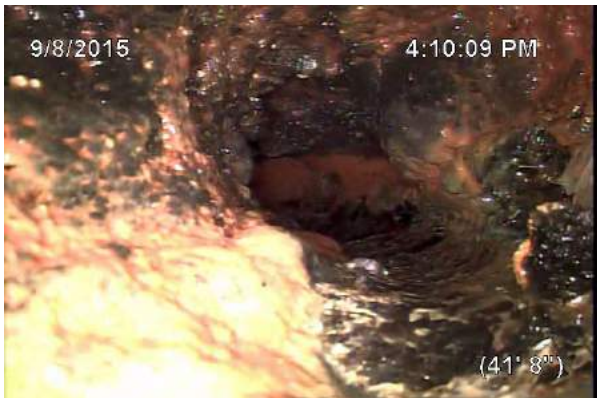
41' 8"

9/8/2015 4:10:08 PM
End inspection. MSA - miscellaneous survey abandoned due to heavy grease deposits (over 30% of diameter) preventing further progress. End continuous surface corrosion (SCP).

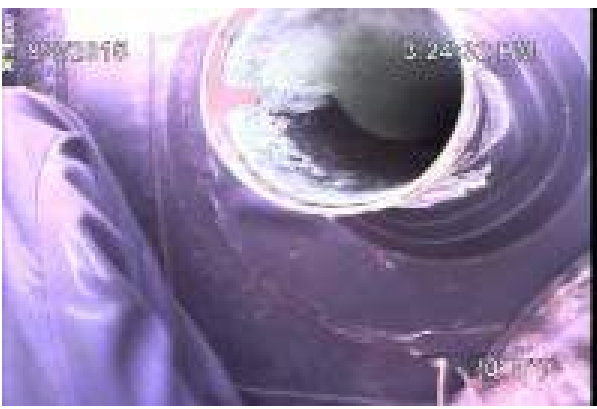
0' 0"

Start inspection. Access Sewer Riser. SCP - surface corrosion (scaling) - continuous.

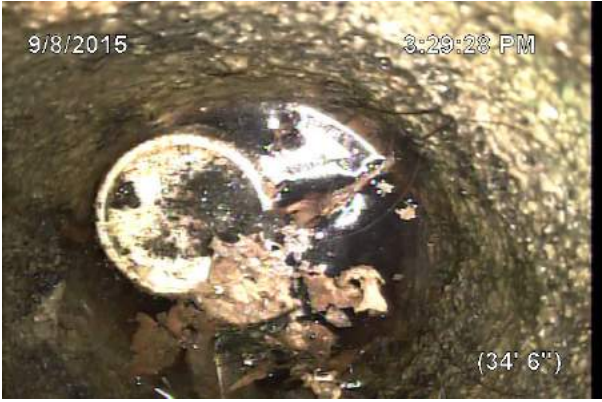
Defect score: 5 - pipe exhibits heavy corrosion and 100% blockage at 34'.

9/8/2015 3:29:28 PM 34' 6"
100% blocked. End inspection. MSA - survey abandoned due to complete blockage. End continuous surface corrosion (SCP).

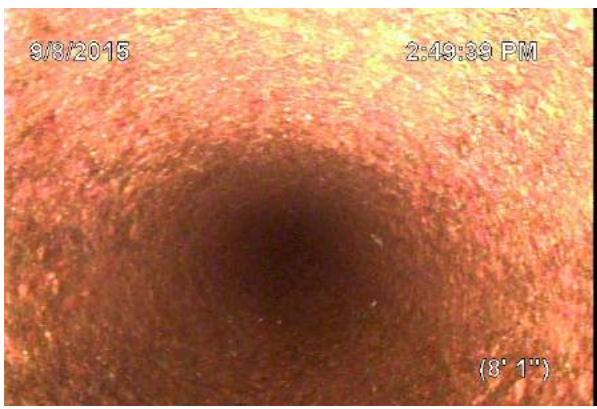
8' 1"

SCP - surface corrosion (scaling) - continuous.

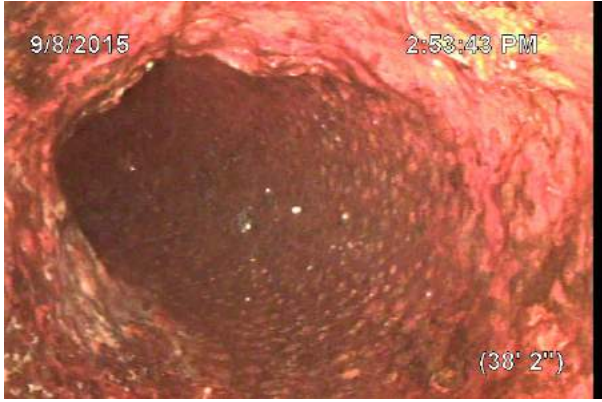
38' 2"

Sweeping 90 degree bend. End inspection. MSA - survey abandoned at bottom of vertical riser. End continuous scale (SCP).

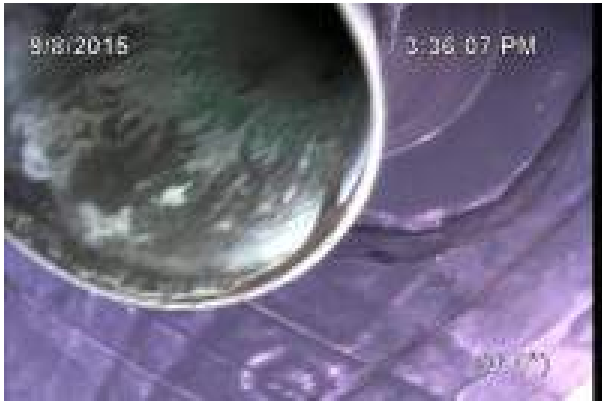
0' 0"

Start inspection. Access Sewer Riser. SCP - surface corrosion (scaling) - continuous.

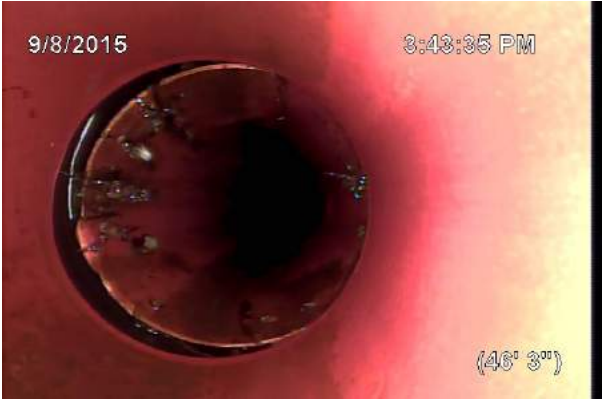
Defect score: 3 - heavy corrosion observed along with sealant leaking in at joint of point repair.

9/8/2015 3:43:35 PM 46' 3"
ISSR - intruding sealing material. End inspection. MSA - survey abandoned due to number of bends. End continuous surface corrosion (SCP).
