## Washington Post Infrastructure Intelligence Study

## CLEANOUT A-B

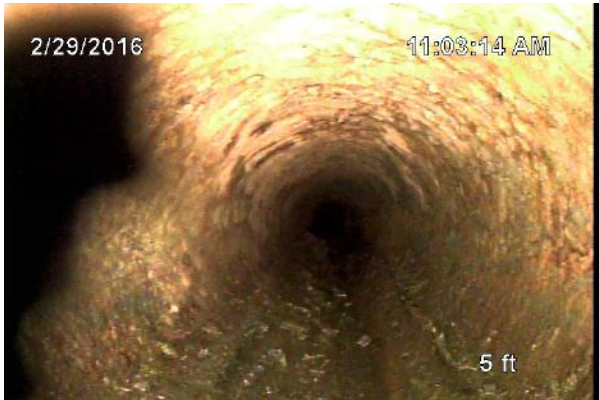
5 ft

2/29/2016 11:03:15 AM  
CL - Linear crack

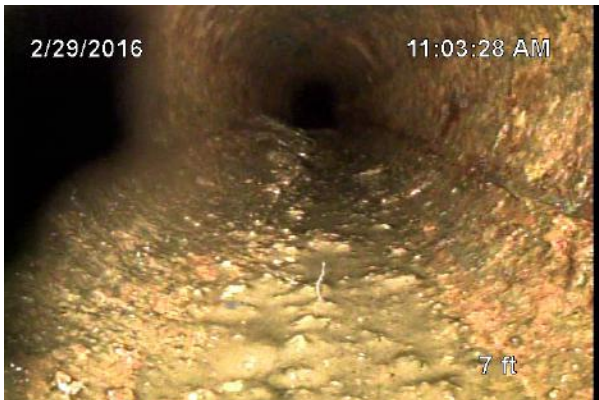
7 ft

2/29/2016 11:03:29 AM  
Debris

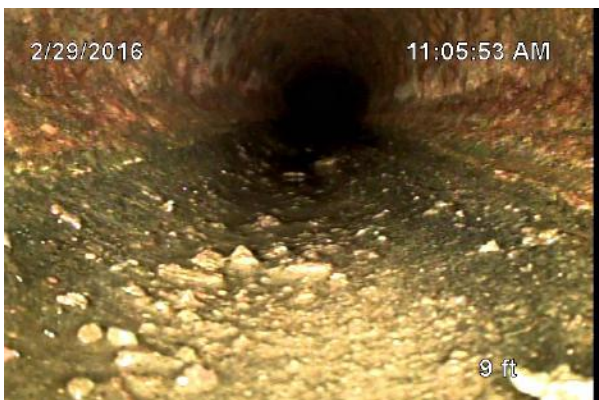
9 ft

2/29/2016 11:05:53 AM  
CL - Linear crack

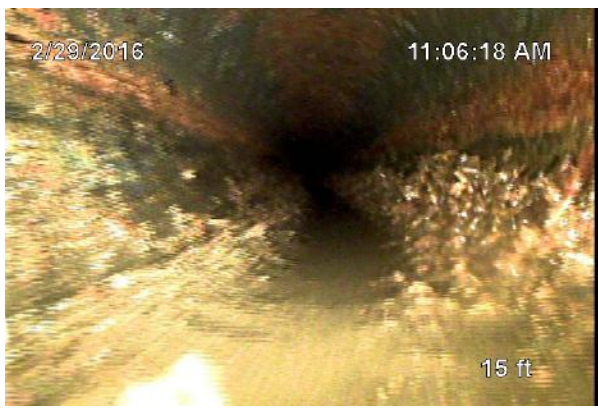
15 ft

SCP - surface corrosion and debris present - continuous.

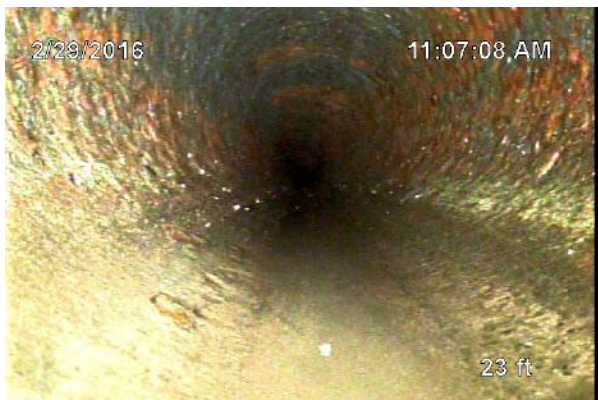
23 ft

SCP - surface corrosion and debris present - end continuous.

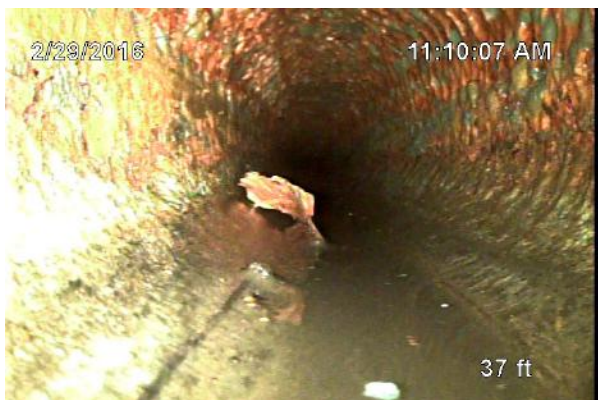
37 ft

CL - Linear crack D-Debris

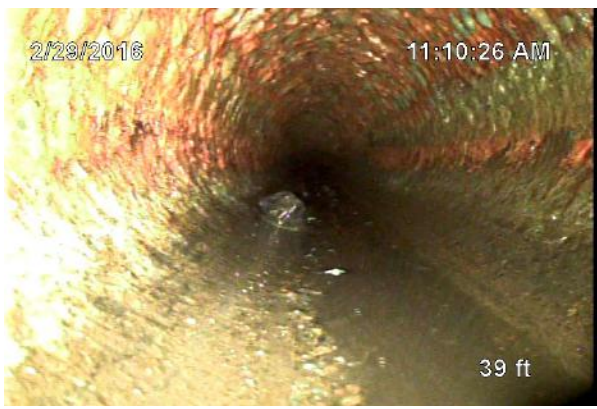
39 ft

2/29/2016 11:10:26 AM  
D-Debris

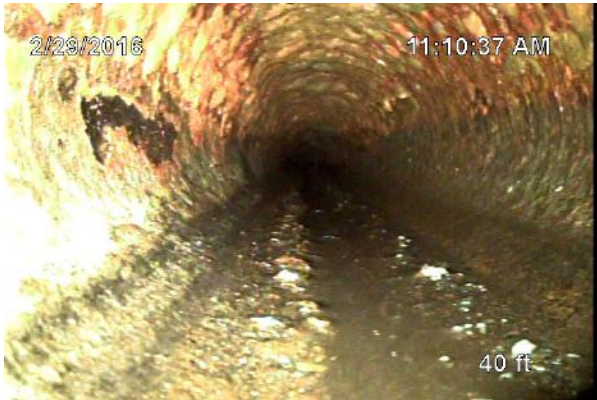
40 ft

2/29/2016 11:10:37 AM  
SRI - surface roughness increasing

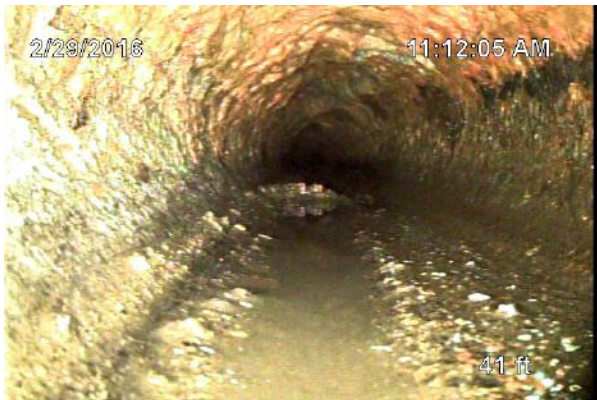
41 ft

2/29/2016 11:12:05 AM  
DNZ - deposits attached > 20% of pipe diameter.

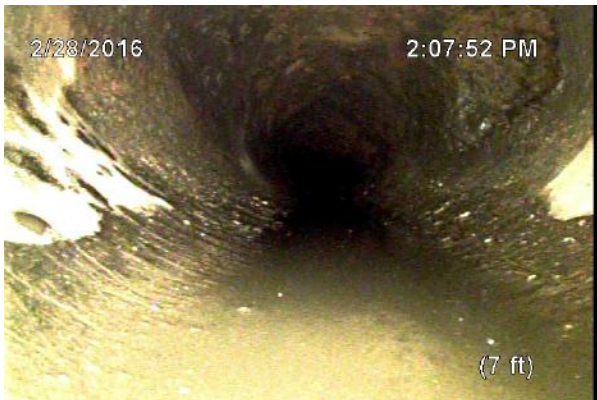
7 ft

2/28/2016 2:07:52 PM  
SCP - surface corrosion present - continuous. 4" Connection

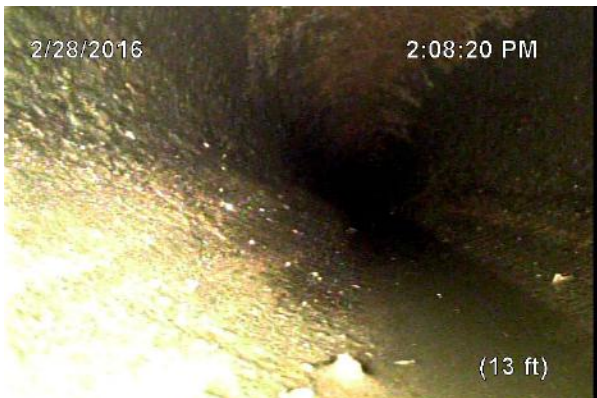
13 ft

2/28/2016 2:08:21 PM  
SRI - surface roughness increasing

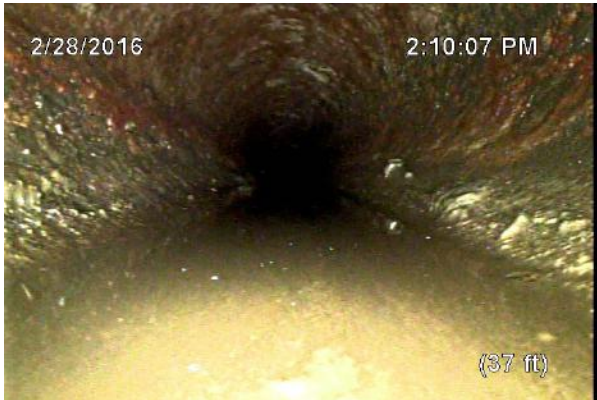
37 ft

2/28/2016 2:10:07 PM  
Belly.

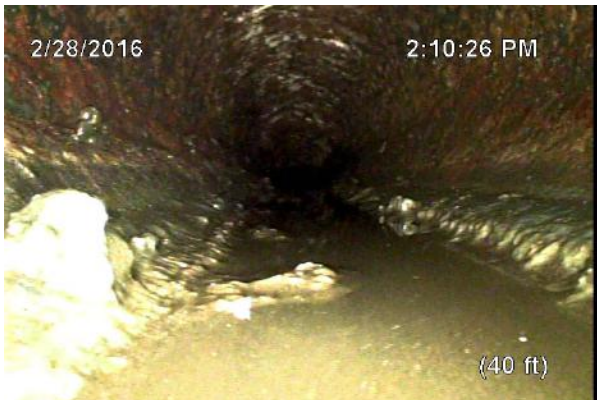
40 ft

2/28/2016 2:10:26 PM  
DNZ - general observation of deposits attached.

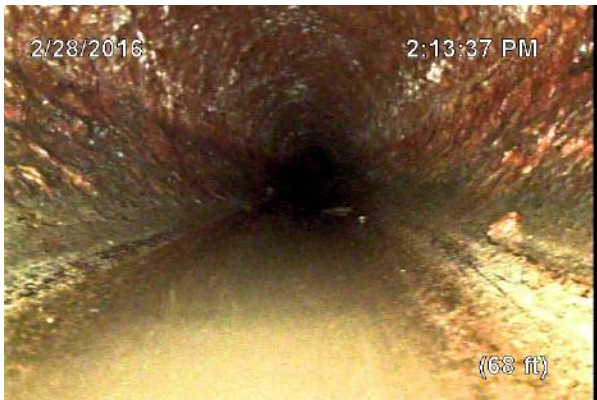
68 ft

2/28/2016 2:13:38 PM  
CL - Linear crack

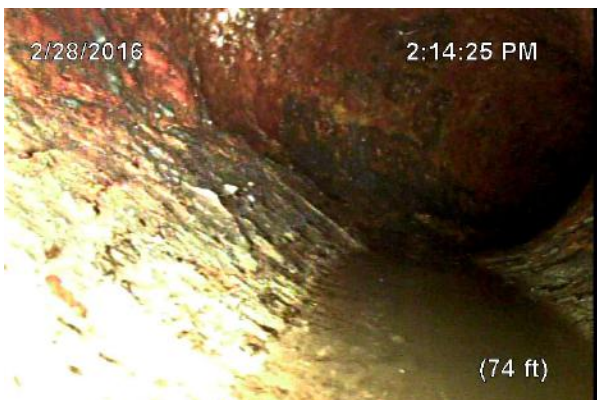
74 ft

2/28/2016 2:14:26 PM  
SCP - surface corrosion present - end continuous.

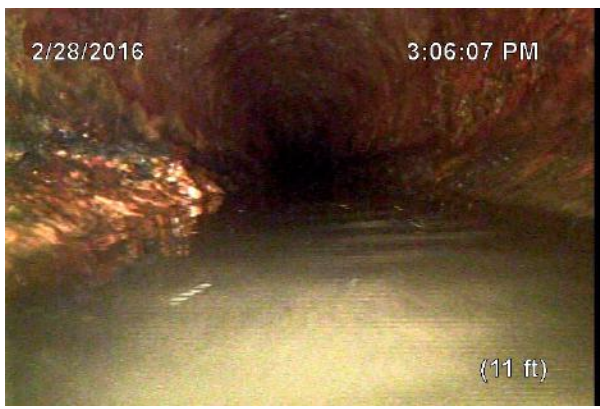
11 ft

2/28/2016 3:06:08 PM  
Belly.

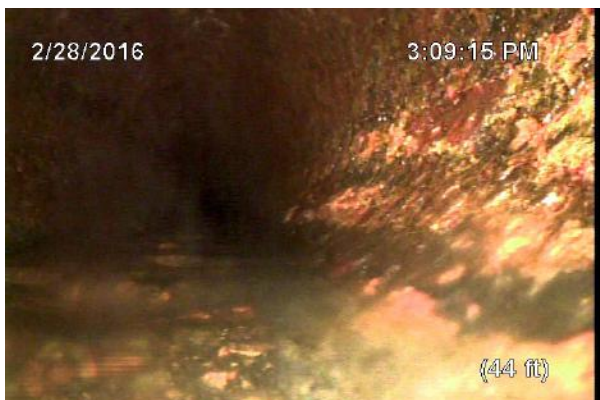
44 ft

2/28/2016 3:09:15 PM  
D-Debris

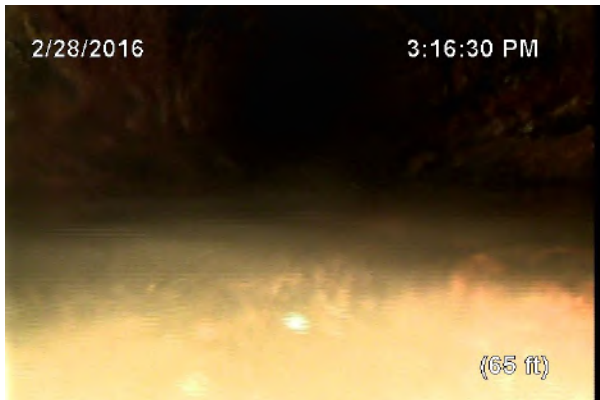
65 ft

2/28/2016 3:16:31 PM  
Belly.

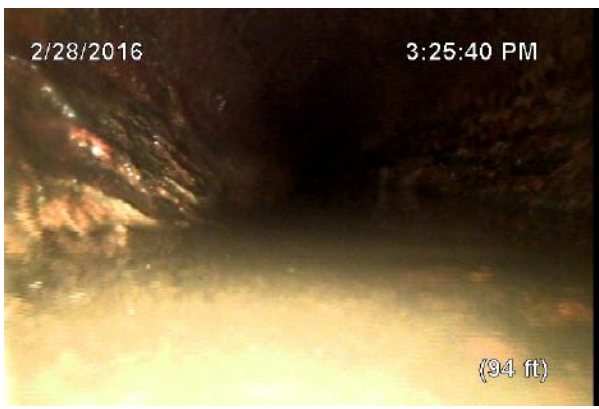
94 ft

2/28/2016 3:25:40 PM  
Belly

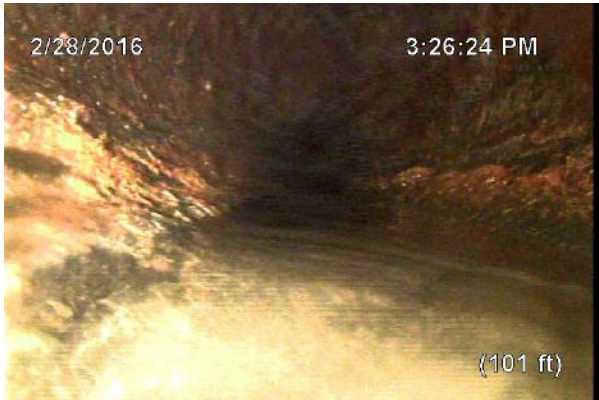
101 ft

2/28/2016 3:26:25 PM  
SCPD - surface corrosion and debris present

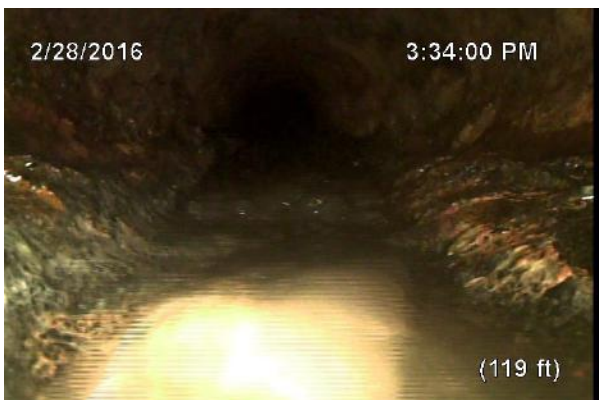
119 ft

2/28/2016 3:34:00 PM  
Belly.

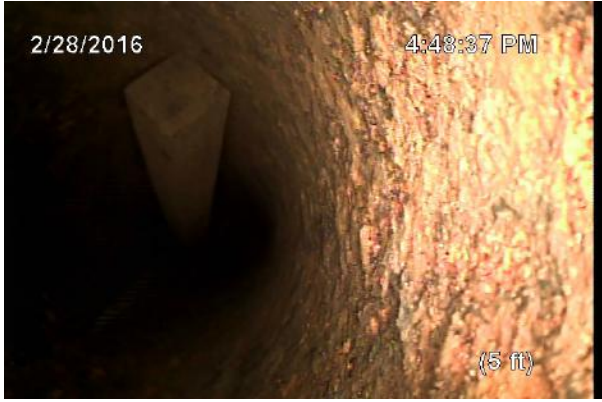
5 ft

2/28/2016 4:48:37 PM  
Obstruction-Wood 1"x3' long.

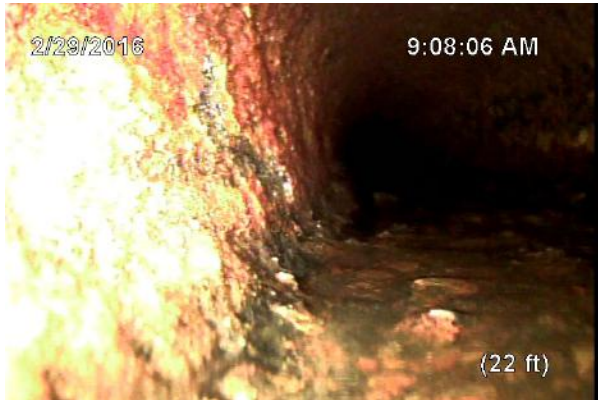
22 ft

2/29/2016 9:08:07 AM  
B-belly continuous end

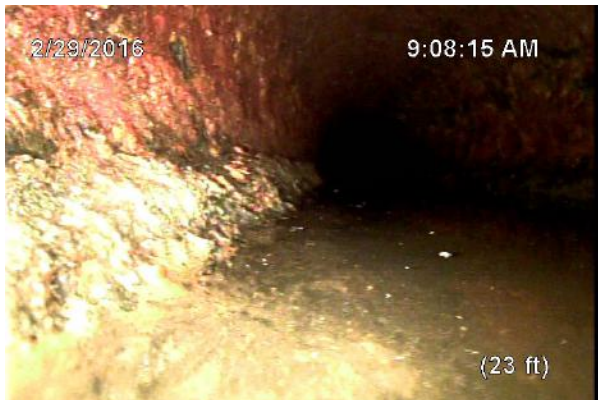
23 ft

2/29/2016 9:08:16 AM  
SRI - surface roughness increasing

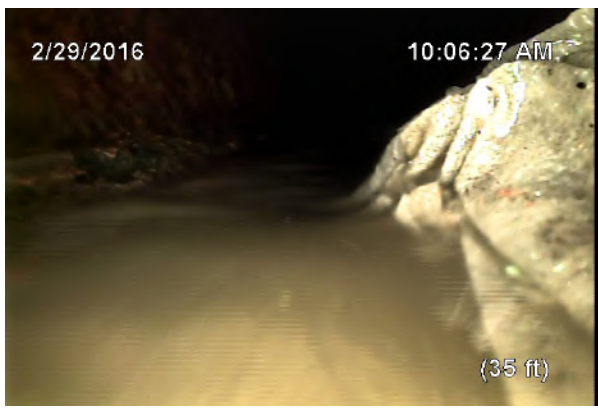
35 ft

2/29/2016 10:06:27 AM  
DAR - attached ragging

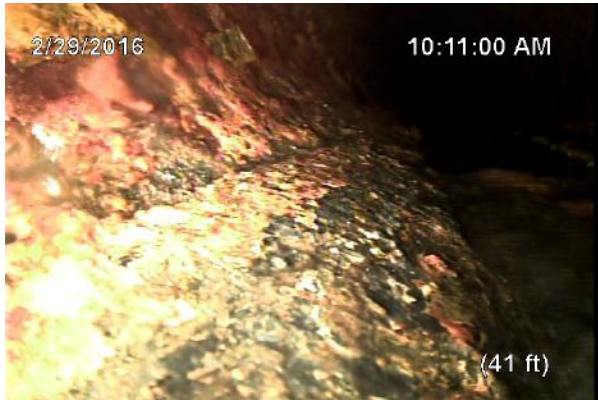
41 ft

2/29/2016 10:11:00 AM  
BC- bottom channeling

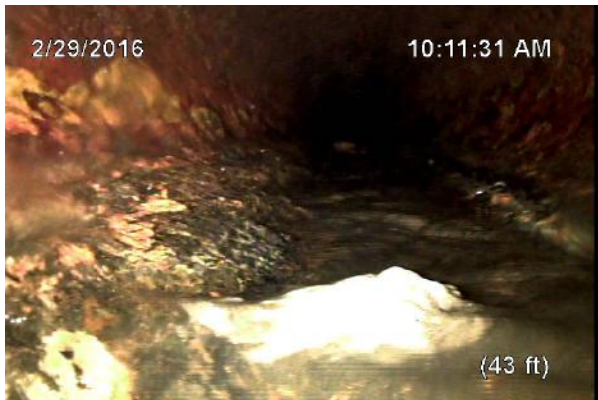
43 ft

2/29/2016 10:11:31 AM  
DAR - attached ragging

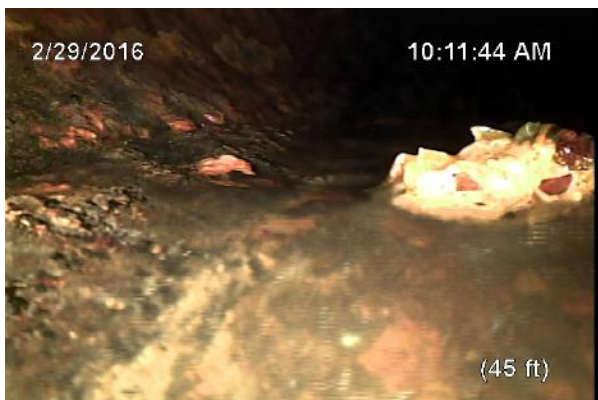
45 ft

2/29/2016 10:11:44 AM  
D-Debris

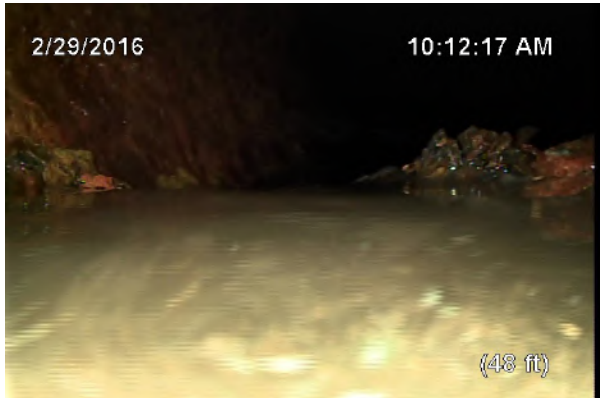
48 ft

2/29/2016 10:12:17 AM  
D-Debris

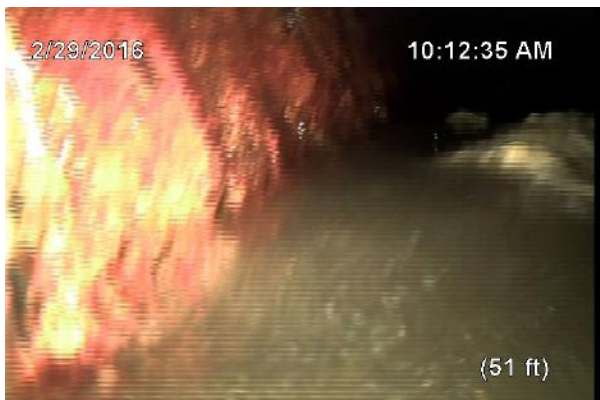
51 ft

2/29/2016 10:12:36 AM  
DAR - attached ragging

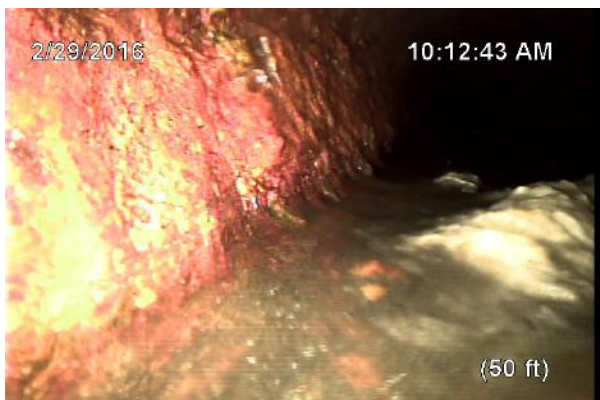
50 ft

2/29/2016 10:12:44 AM  
DAR - attached ragging

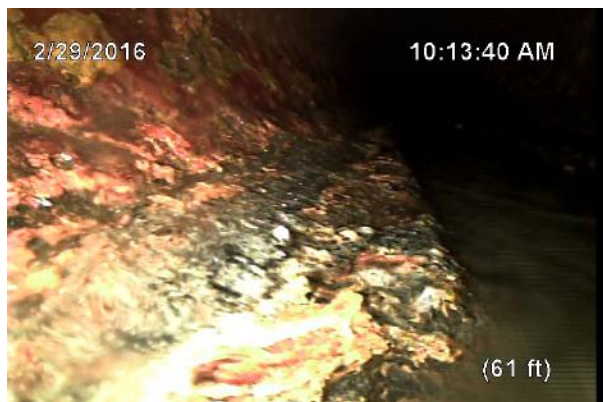
61 ft

2/29/2016 10:13:40 AM  
BC- bottom channeling

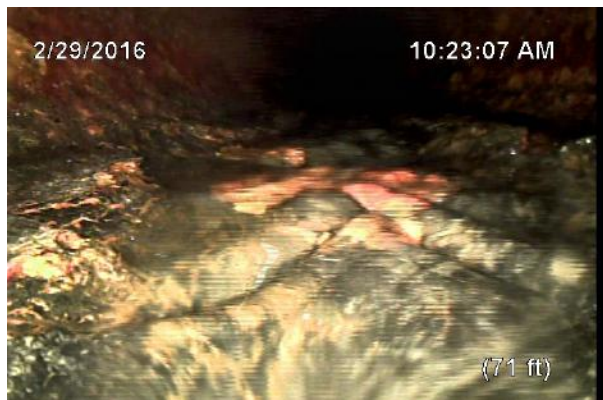
71 ft

2/29/2016 10:23:07 AM  
BC- bottom channeling

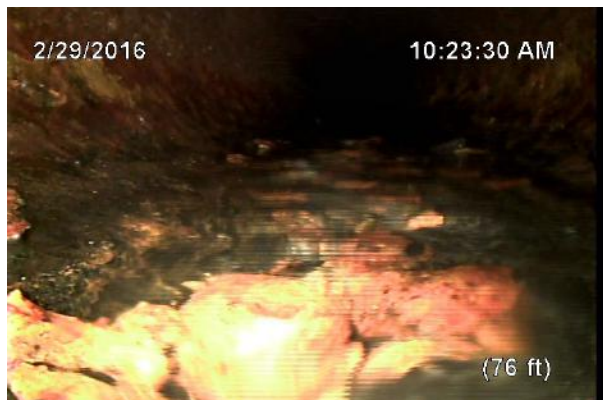
76 ft

2/29/2016 10:23:31 AM  
D-Debris

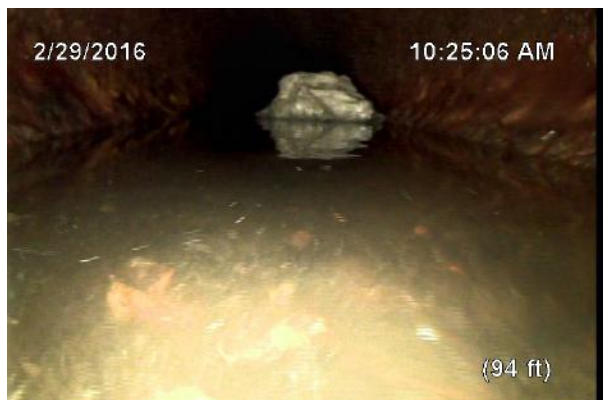
94 ft

2/29/2016 10:25:07 AM  
DAR - attached ragging

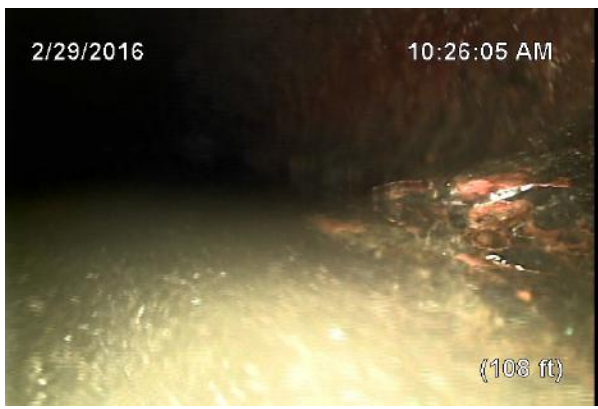
108 ft

2/29/2016 10:26:06 AM  
BC- bottom channeling
