Bolling Brook Sewer Riser Inspections - Building 3242

A Sanitary Sewer Evaluation Study is a technological method of scoring piping defects within sewer infrastructure. This top down method incorporates: surveys, pipe inspections, and evaluation concepts into a turnkey, professional service delivering detailed, conditional assessments for any major collection system. Our analytical process digitally overlays pipe locations with each pipes' conditional data points to provide a concise, quantifiable survey that are scored relative to the risk of the infrastructure failing. This information serves as an invaluable tool for assessing and planning short and long-term infrastructure rehabilitation projects.

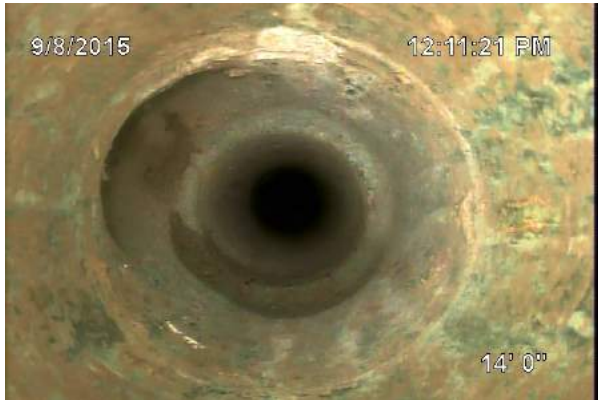
4' 6"

2" Connection. SCP - surface corrosion present - continuous.

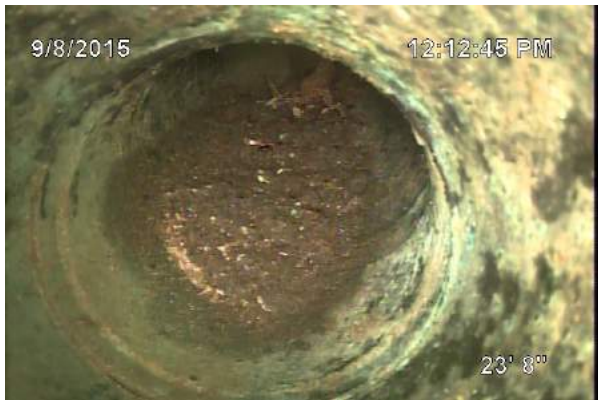
14' 0"

2" Connection

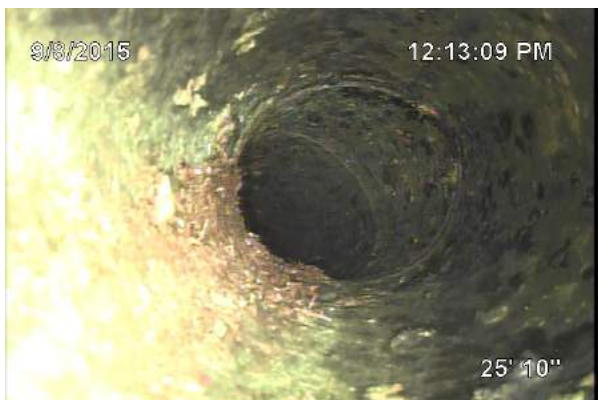
23' 8"

90 Degree bend.

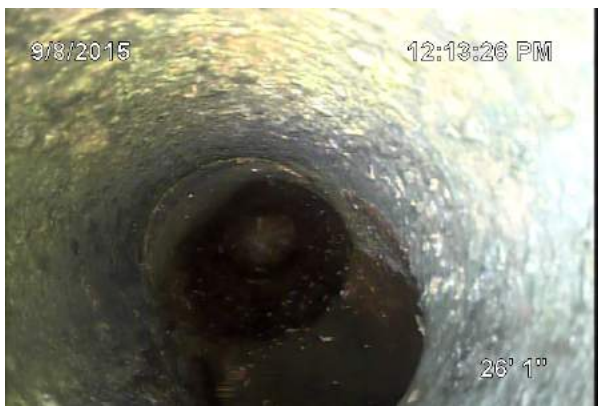
25' 10"

90 degree bend.

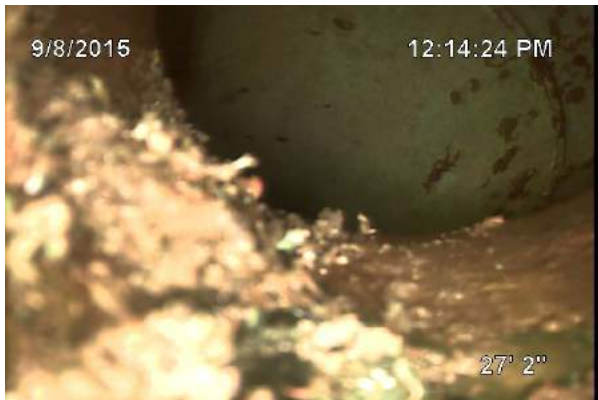
26' 8"

9/8/2015 12:14:03 PM
90 Degree bend. DNZ - general foreign debris in pipe.

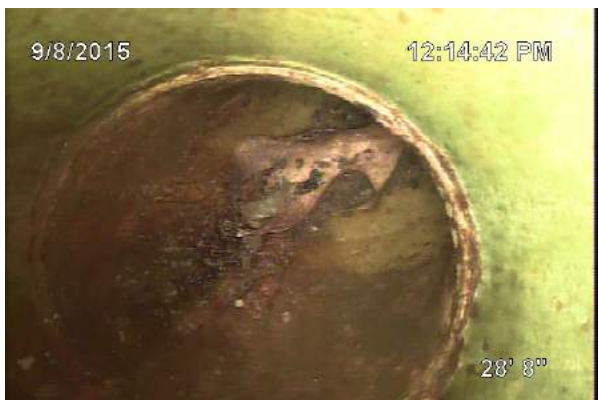
27' 2"

9/8/2015 12:14:24 PM
90 degree bend

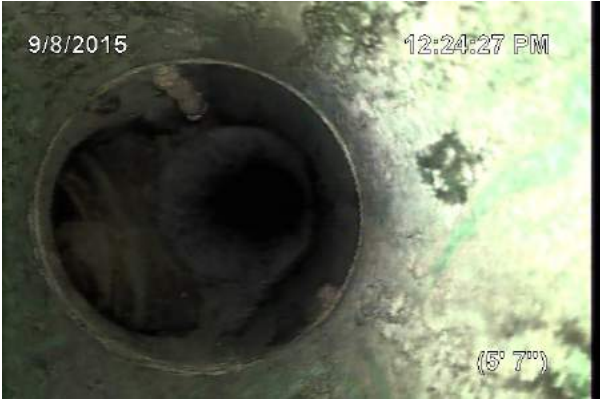
9/8/2015 12:24:28 PM 5' 7"

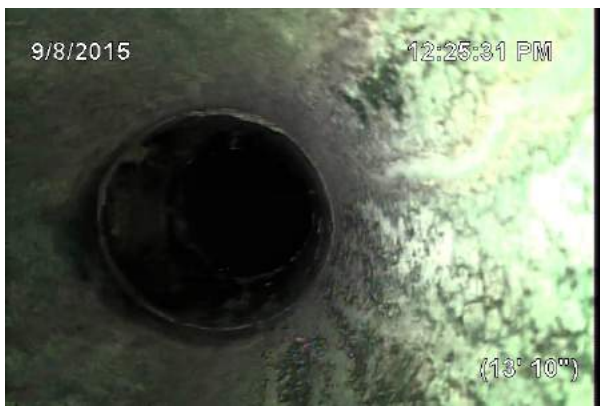
13' 10"

9/8/2015 12:25:32 PM
2" connection

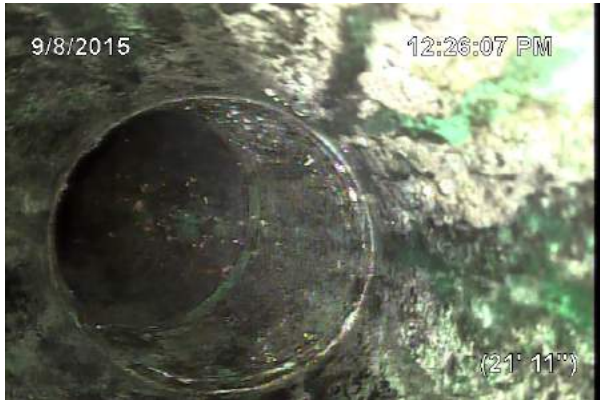
21' 11"

9/8/2015 12:26:08 PM
90 degree bend

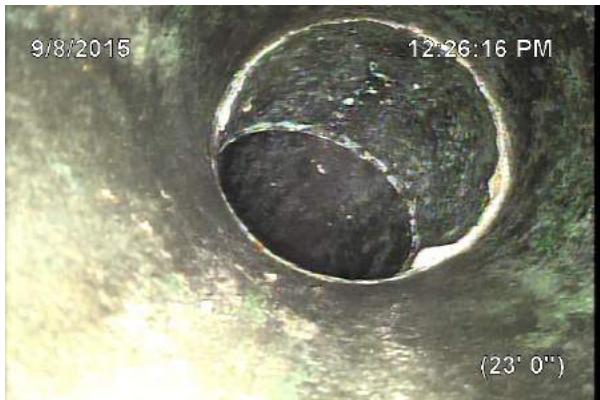
23' 0"

9/8/2015 12:26:16 PM
90 degree bend

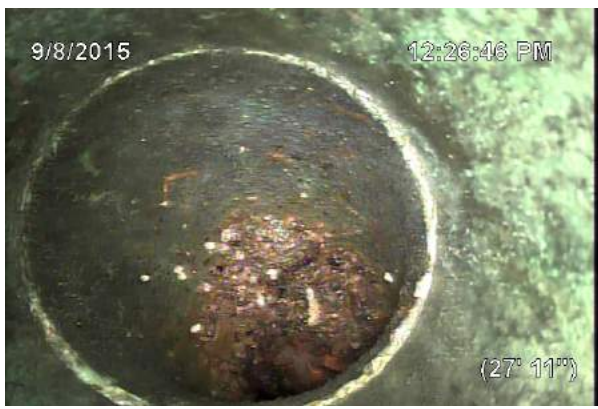
27' 11"

9/8/2015 12:26:47 PM
90 degree bend.

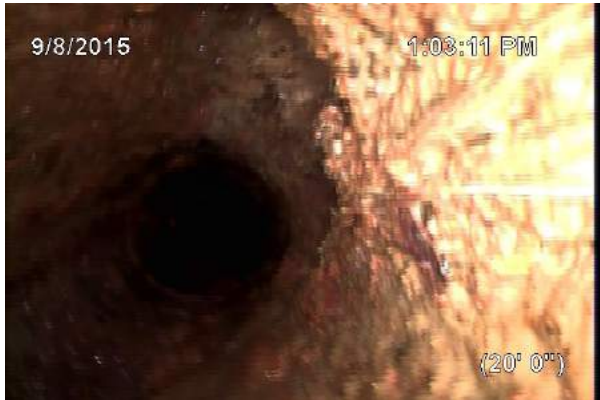
20' 0"

9/8/2015 1:03:11 PM
4" Combo Connection

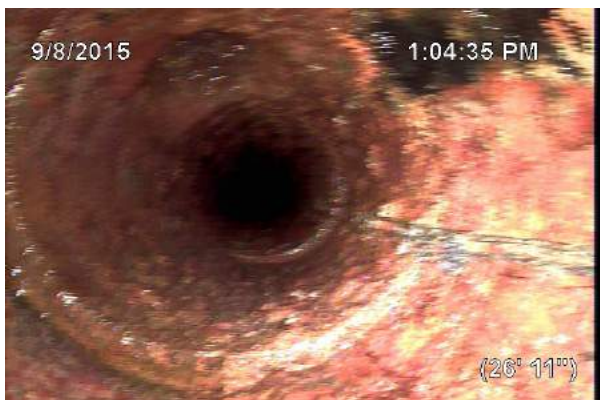
26' 11"

9/8/2015 1:04:36 PM
3" connection

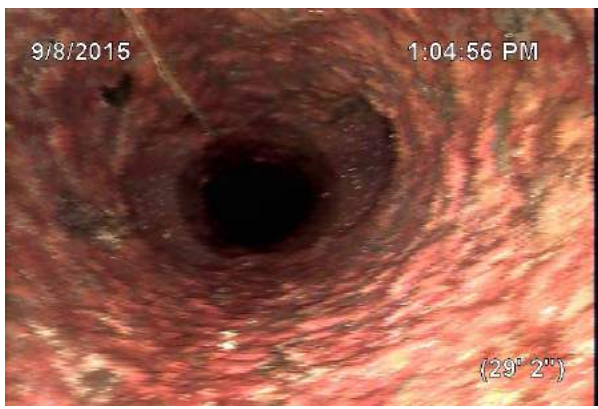
29' 2"

9/8/2015 1:04:56 PM
4" Combo Connection

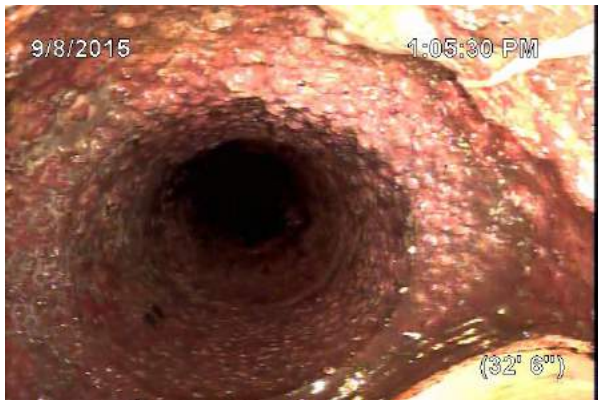
32' 6"

9/8/2015 1:05:30 PM
Cleanout

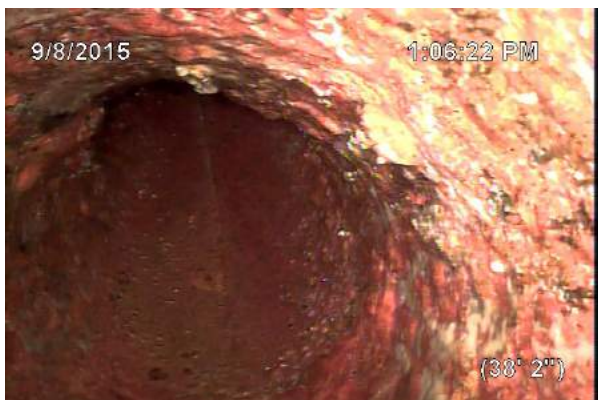
38' 2"

9/8/2015 1:06:23 PM
Sweeping 90 degree bend.

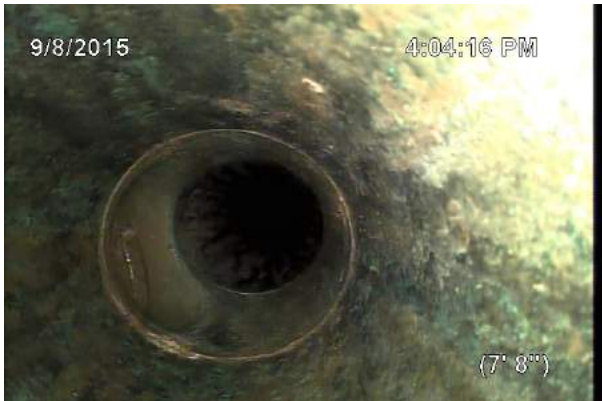
7' 8"

2" connection

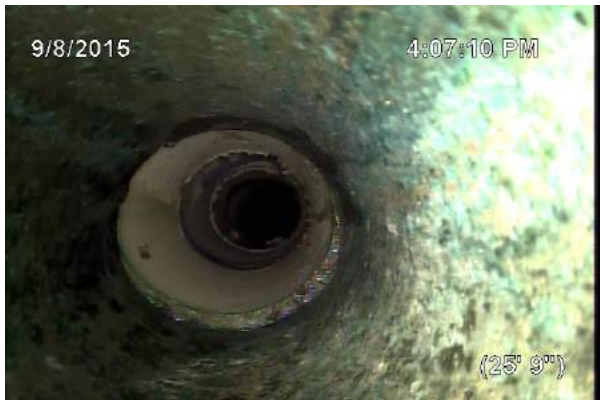
25' 9"

9/8/2015 4:07:11 PM
MMC - material change to PVC

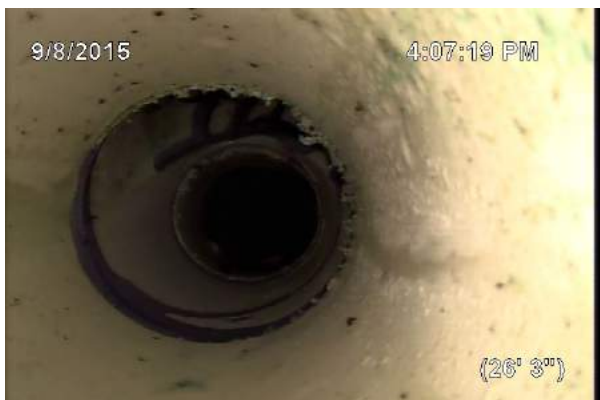
26' 3"

9/8/2015 4:07:19 PM
2" connection

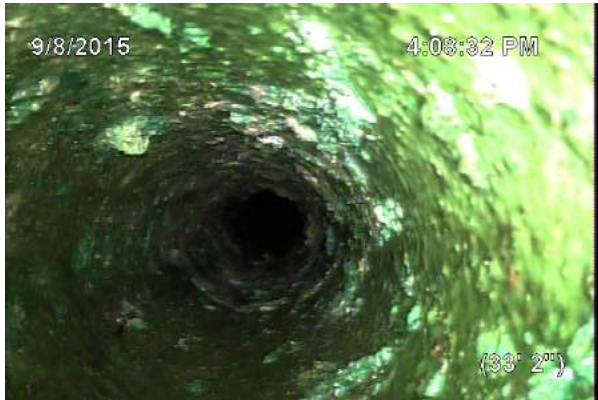
33' 2"

9/8/2015 4:08:32 PM
SRI - Surface Roughness Increasing

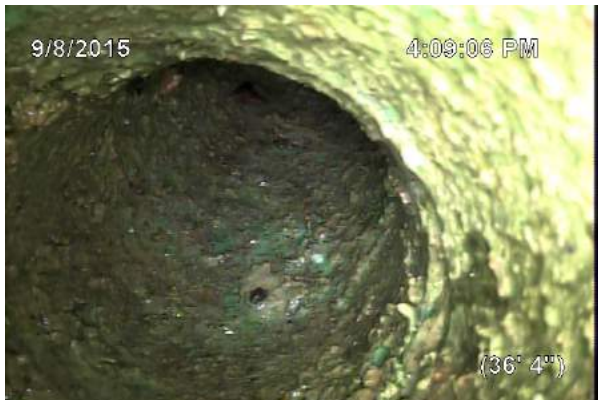
36' 4"

9/8/2015 4:09:07 PM
90 degree bend.

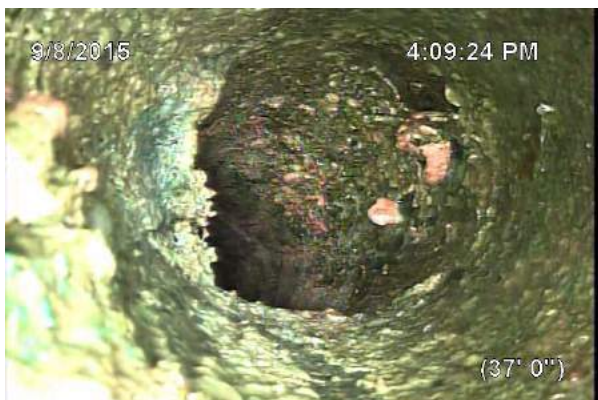
37' 0"

9/8/2015 4:09:24 PM
45 degree bend

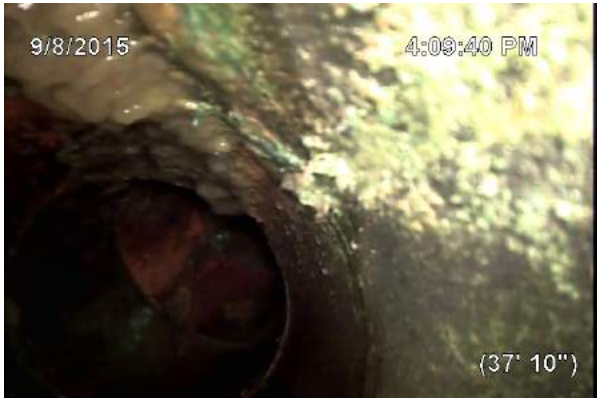
37' 10"

9/8/2015 4:09:40 PM
90 degree bend. DAGS - grease deposits.

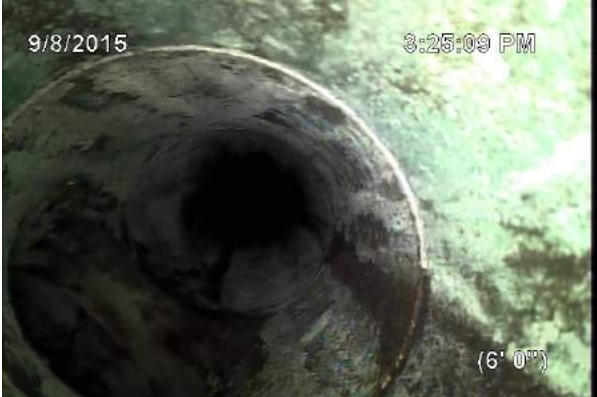
6' 0"

2" connection

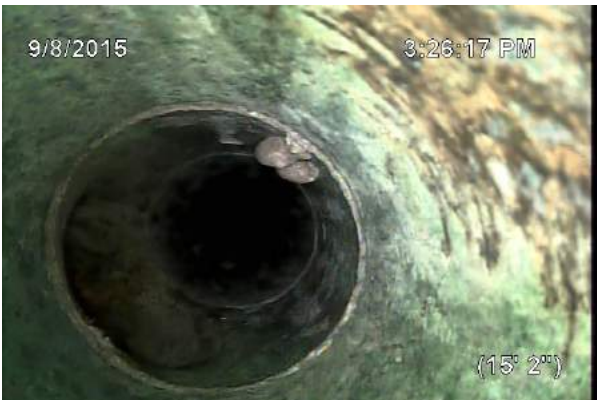
15' 2"

2" connection

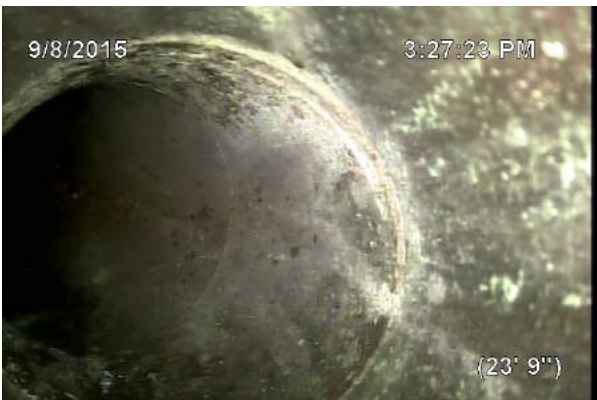
23' 9"

90 degree bend

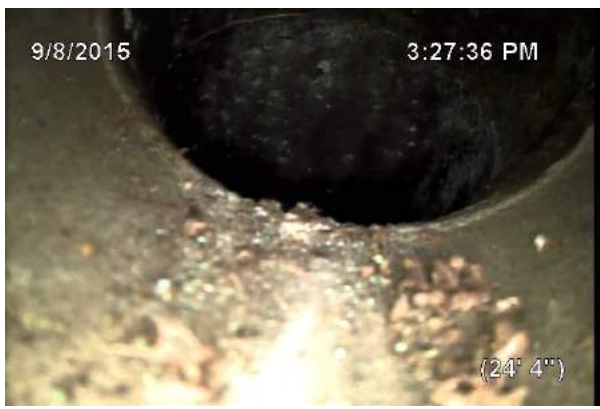
24' 4"

9/8/2015 3:27:37 PM
90 degree bend

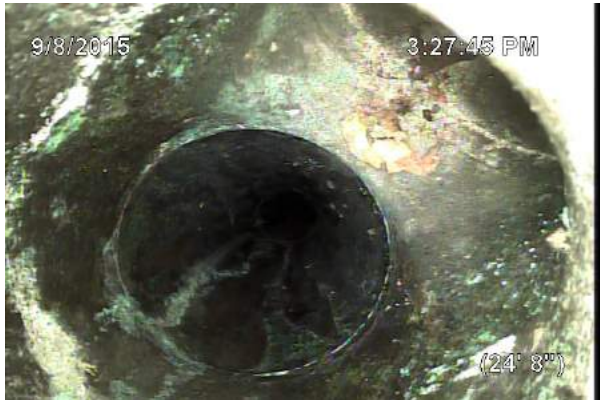
24' 8"

9/8/2015 3:27:45 PM
2" connection

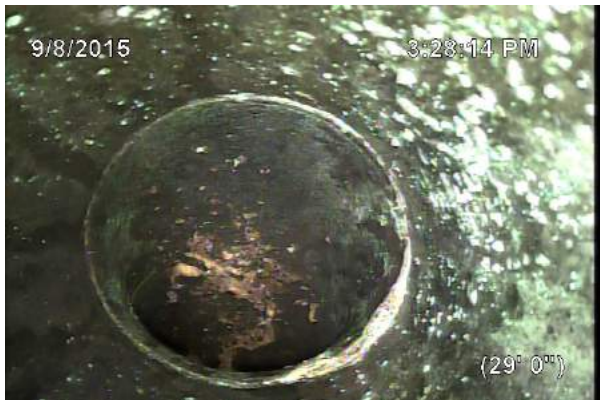
29' 0"

9/8/2015 3:28:15 PM
90 degree bend

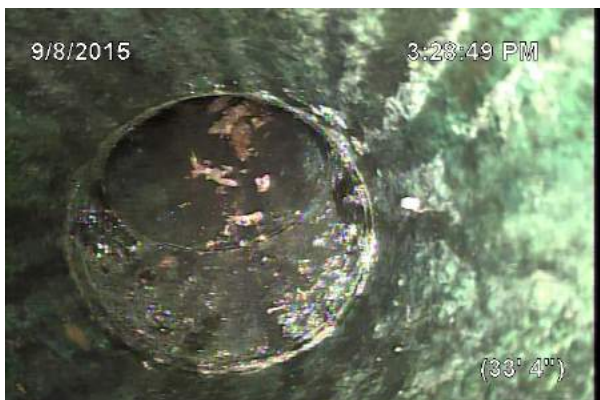
33' 4"

9/8/2015 3:28:49 PM
90 degree bend. SRI - surface roughness increasing.

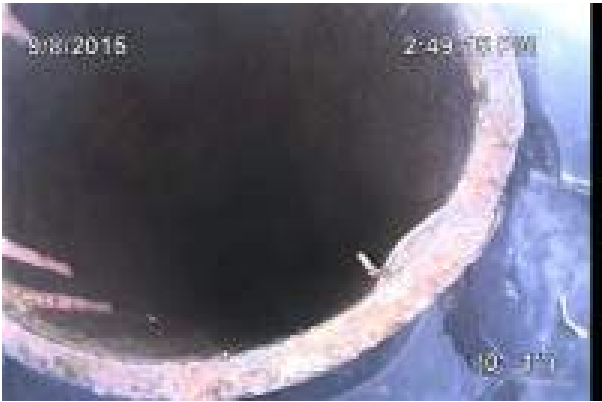
9/8/2015 2:49:16 PM 0' -1"
Start inspection. Access Sewer Riser.

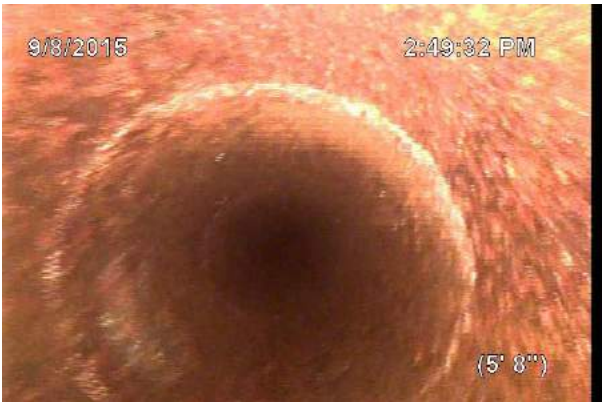
9/8/2015 2:49:32 PM 5' 8"
2" connection

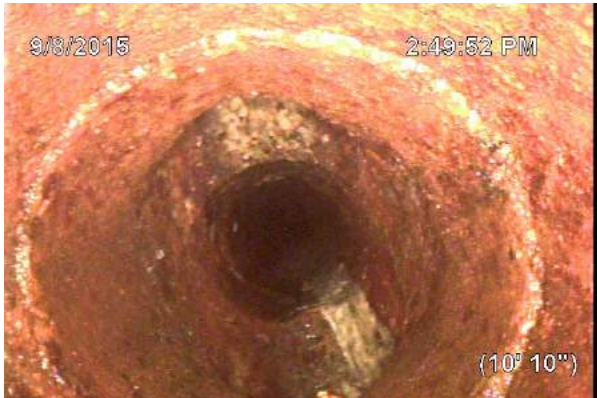
8' 1"

SCP - surface corrosion (scaling) - continuous.

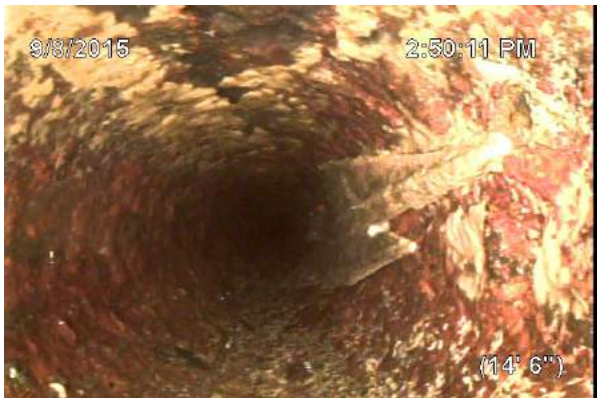
10' 10"

Combo connection. 3" connection @ 11 o'clock. 3" connection @ 5 o'clock.

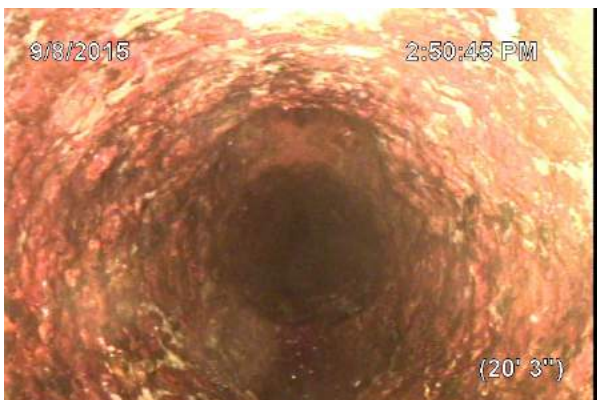
14' 6"

DAR - ragging deposits.

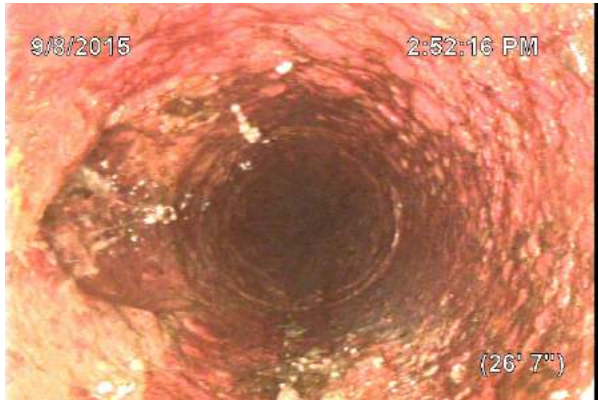
20' 5"

9/8/2015 2:50:50 PM
4" Combo Connection

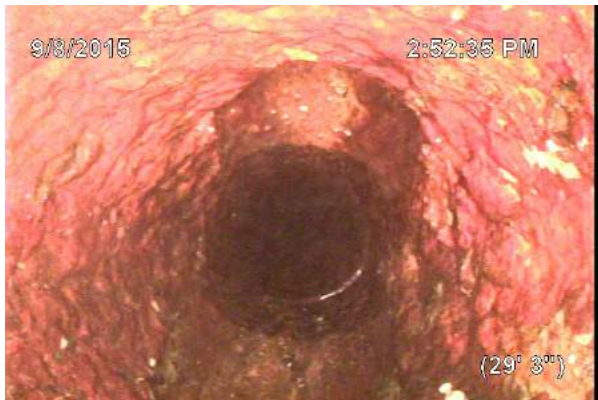
26' 7"

9/8/2015 2:52:17 PM
3" connection

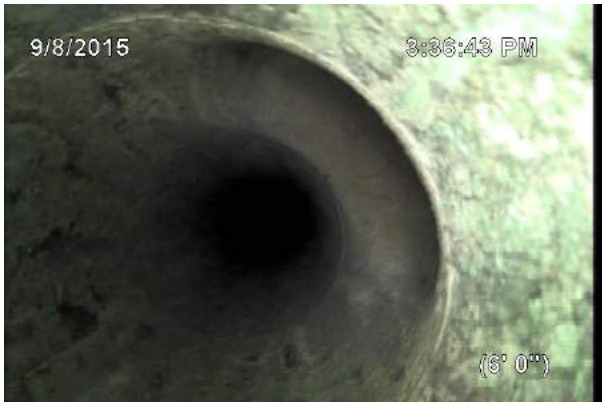
6' 0"

2" connection

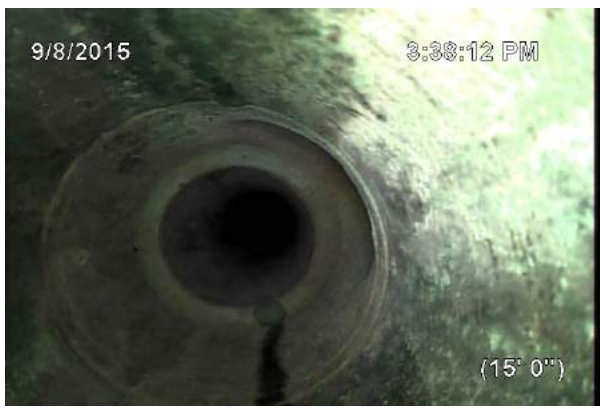
15' 0"

2" connection. Diameter transition from 2" to 1.5".

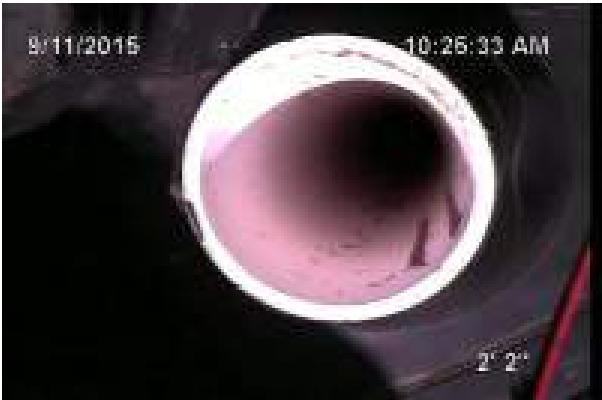
9/11/2015 10:25:33 AM 2' 2"
Start inspection. Access Sewer Riser.

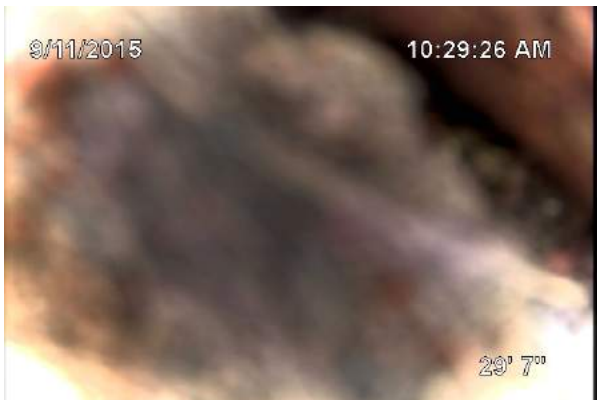
29' 7"

Defect score: 2 - only observed defect is 30% offset to horizontal slab pipe at wye connection.

9/11/2015 10:29:27 AM
Offset joint. End inspection. AEP - end of pipe at horizontal wye connection.

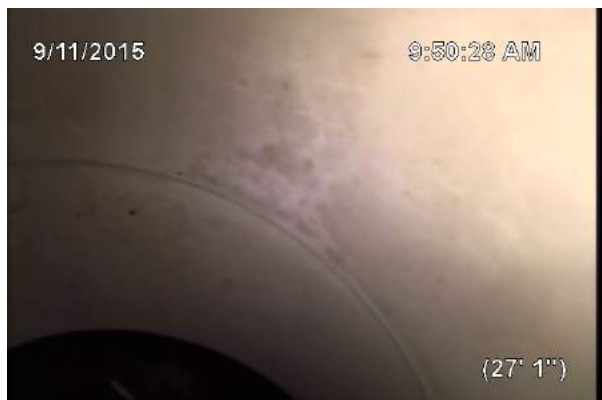
27' 1"

9/11/2015 9:50:29 AM
End inspection. AEP - end of pipe at wye connection.

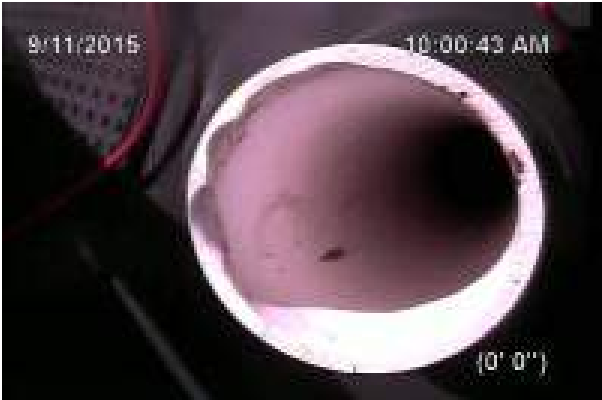
0' 0"

9/11/2015 10:00:43 AM
Start inspection. Access Sewer Riser.

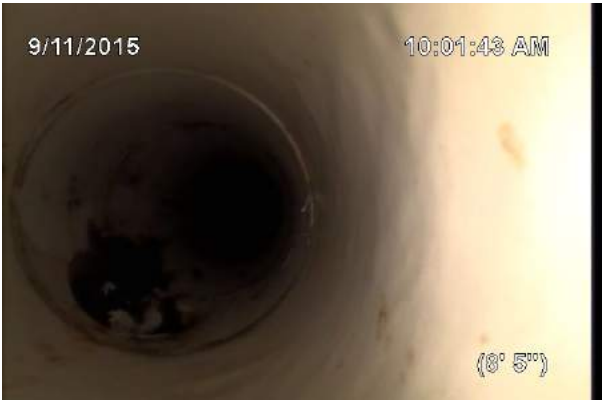
5' 0"

9/11/2015 10:01:18 AM
2" connection

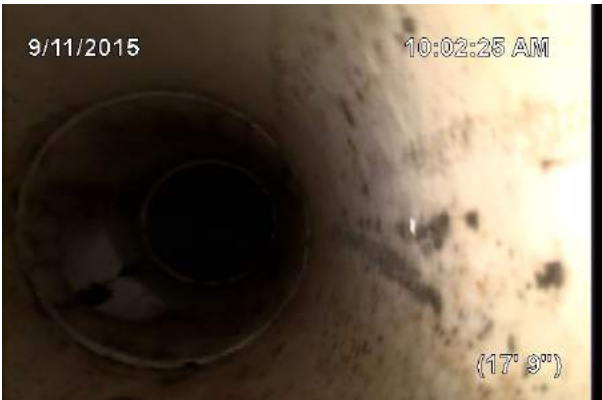
8' 5"

9/11/2015 10:01:44 AM
2" connection

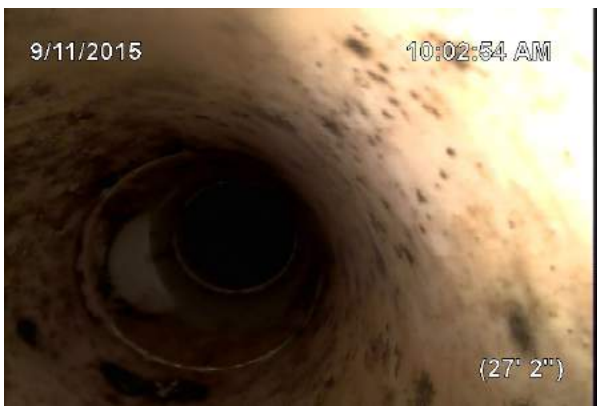
17' 9"

9/11/2015 10:02:26 AM
2" connection

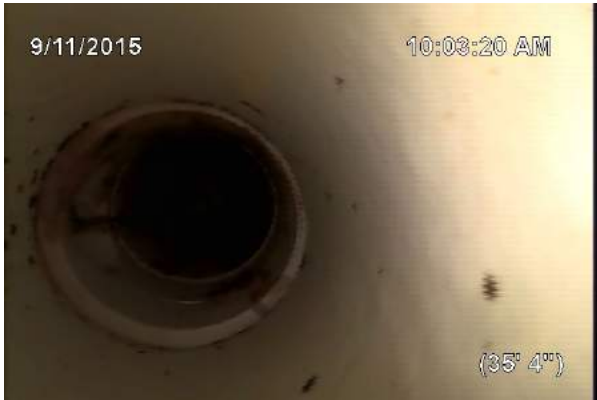
27' 2"

9/11/2015 10:02:54 AM
2" connection

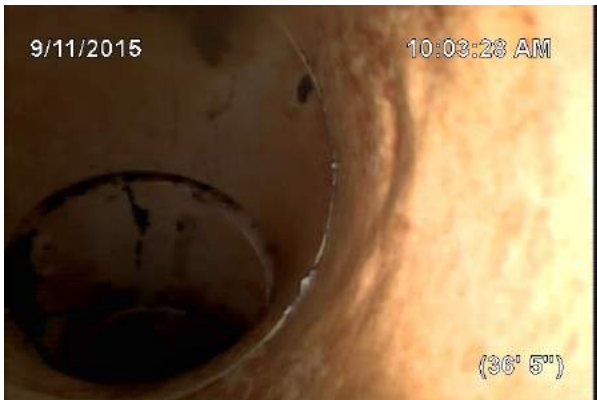
35' 4"

9/11/2015 10:03:21 AM
2" connection

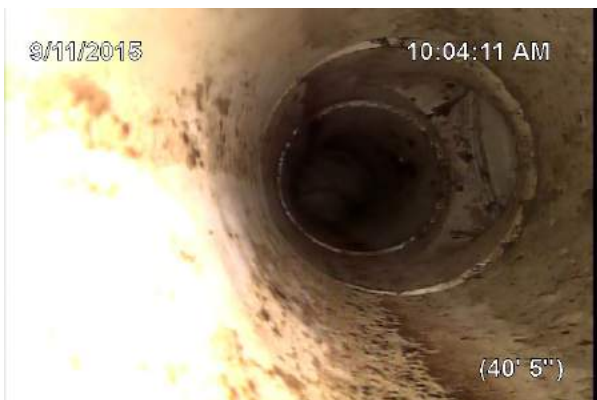
36' 5"

9/11/2015 10:03:28 AM
90 degree bend

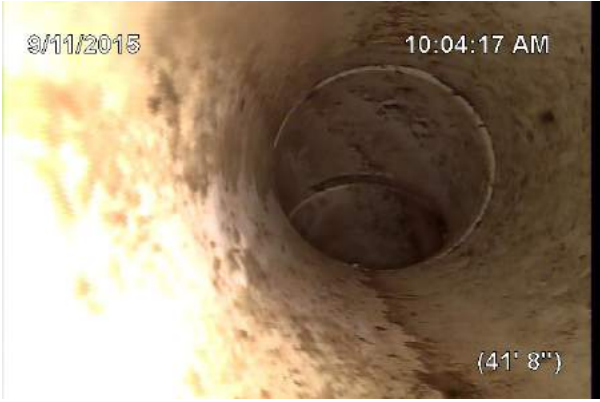
40' 5"

9/11/2015 10:04:11 AM
Cleanout

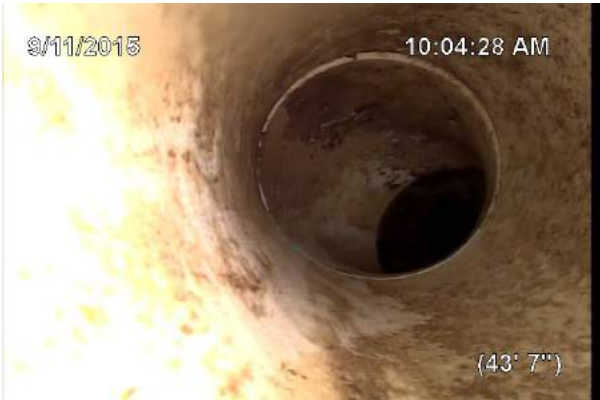
41' 8"

9/11/2015 10:04:18 AM
90 degree bend

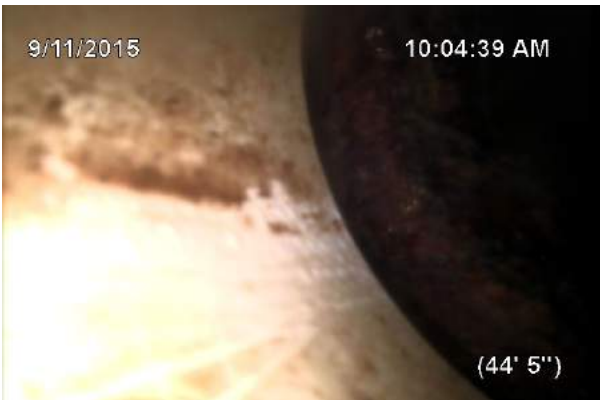
43' 7"

9/11/2015 10:04:29 AM
45 degree bend

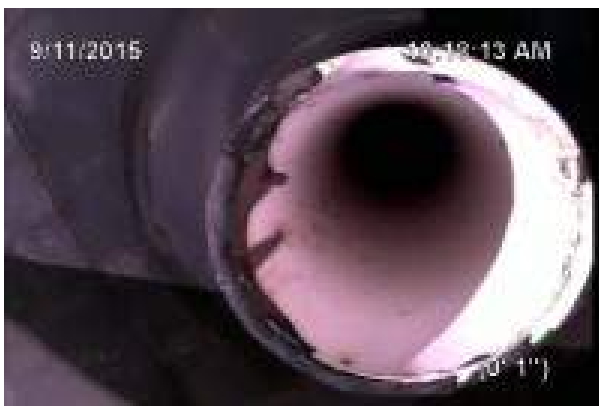
0' 1"

9/11/2015 10:18:13 AM
Start inspection. Access Sewer Riser.

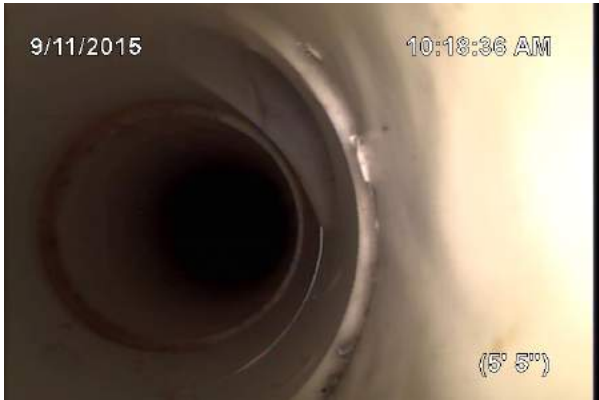
5' 5"

9/11/2015 10:18:36 AM
2" connection

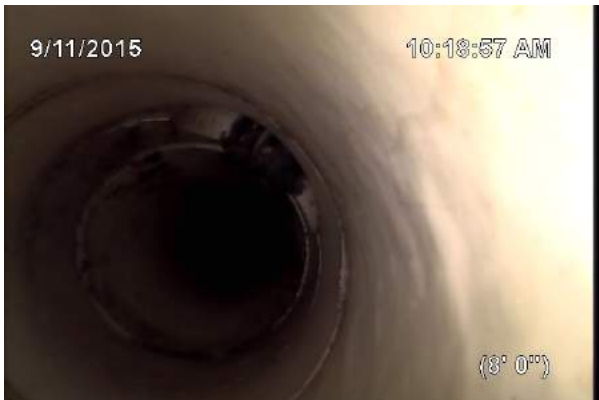
8' 0"

9/11/2015 10:18:57 AM
2" connection

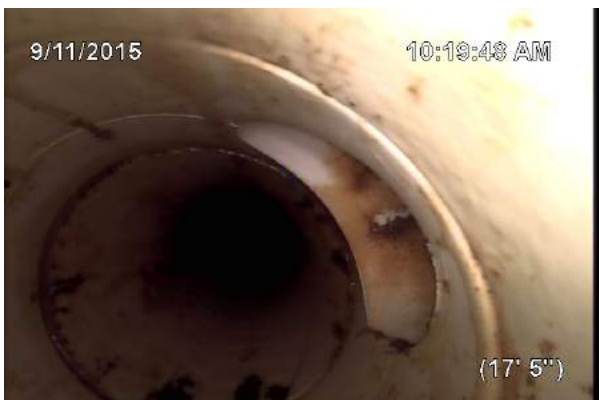
17' 5"

9/11/2015 10:19:48 AM
2" connection

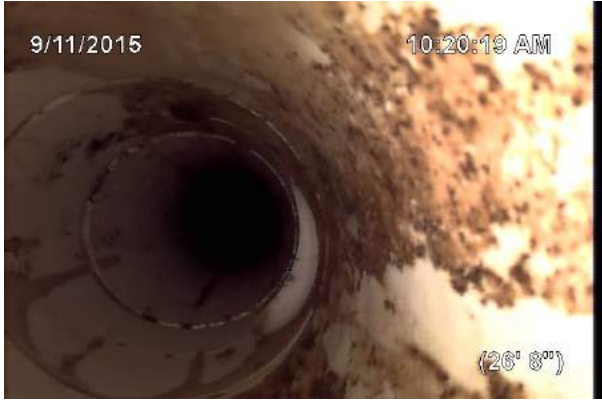
26' 8"

9/11/2015 10:20:20 AM
2" connection

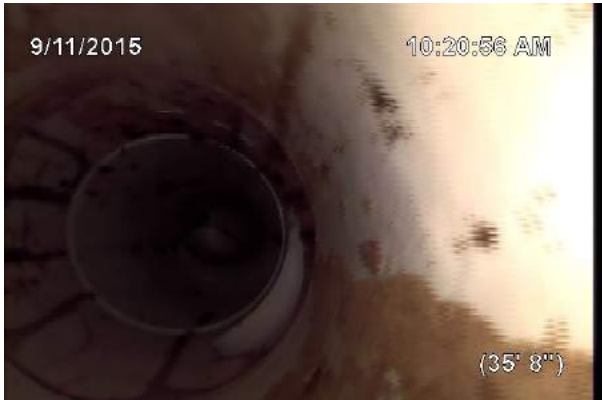
35' 8"

9/11/2015 10:20:57 AM
2" connection

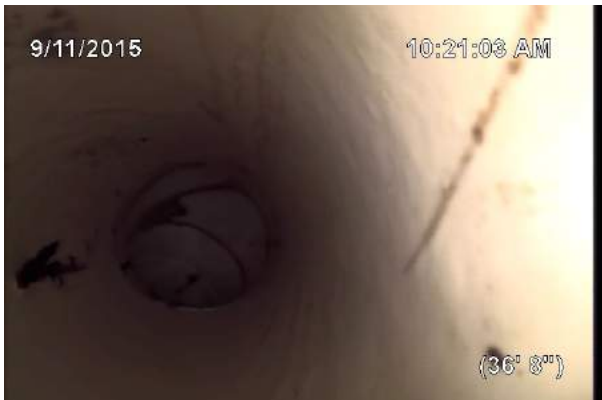
36' 8"

9/11/2015 10:21:03 AM
90 degree bend

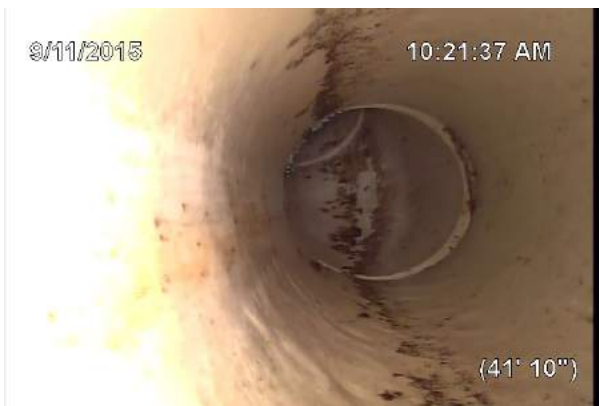
41' 10"

9/11/2015 10:21:38 AM
90 degree bend
